# Manhole Inspection Summary

Manhole # S03SS1010MH

Insp Date: **8/16/06 12:00 AM**

**Location** Address: **5611 Narcissus Ave**

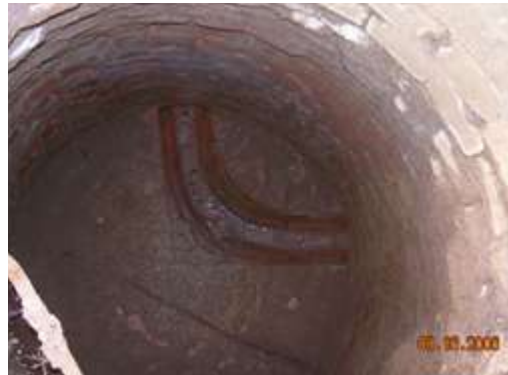
Top View

Adjustment, Corbel, and Barrel infiltration.  
Bench debris.

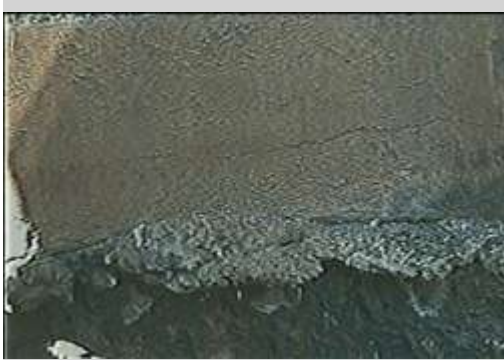
Defect

**Frame** Offset: **0** (in.) Condition: ☐ Sound ☒ **Cracked** ☒ **Leaks**

Condition: ☐ Sound ☐ Cracked ☐ Root Intrusion ☐ Loose Brick ☒ **Deteriorated**

Infiltration: ☐ None ☒ **Joint** ☐ Cracks ☒ **Mortar** ☐ Roots ☐ Wall

Frame cracks. Frame leaks. Adjustment  
deterioration and infiltration.

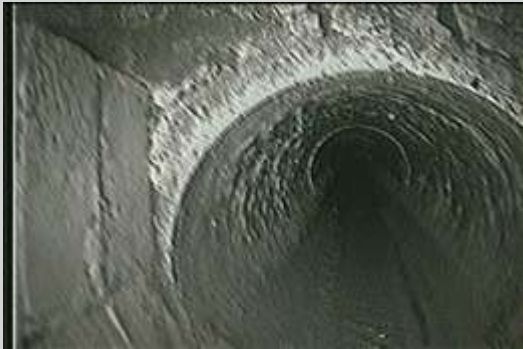
### 8 in. Circular Gravity Sewer Pipe Out @ 12 O'Clock

Infiltration: **Evidence** Pipe Seal Cond: **Unknown**

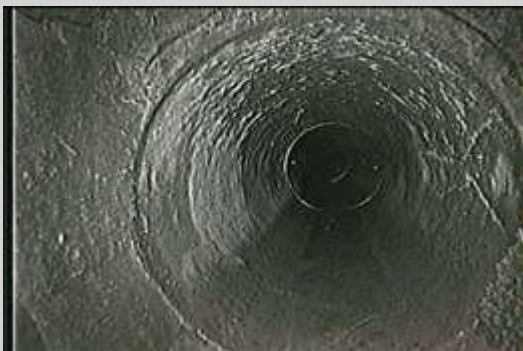
### 8 in. Circular Gravity Sewer Pipe In @ 3 O'Clock

Infiltration: **Evidence** Pipe Seal Cond: **Cracked**
